EXISTING BUILDINGS & FIREPROOFING - TO PATCH OR NOT TO PATCH

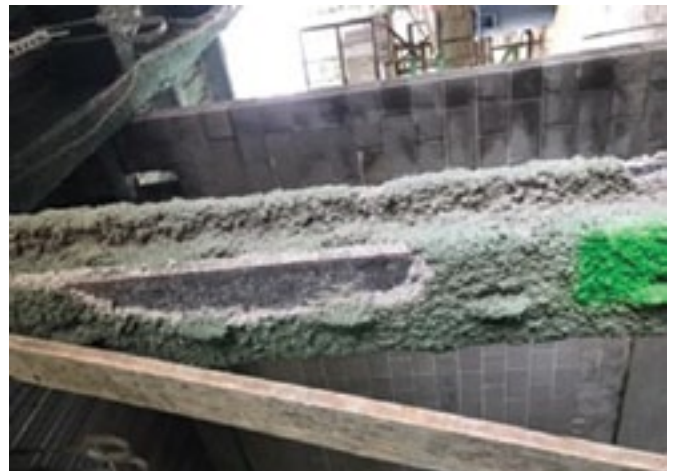
SFRM or IFRM can be damaged during construction, then repairs are needed.
GCP Applied Technologies Photo

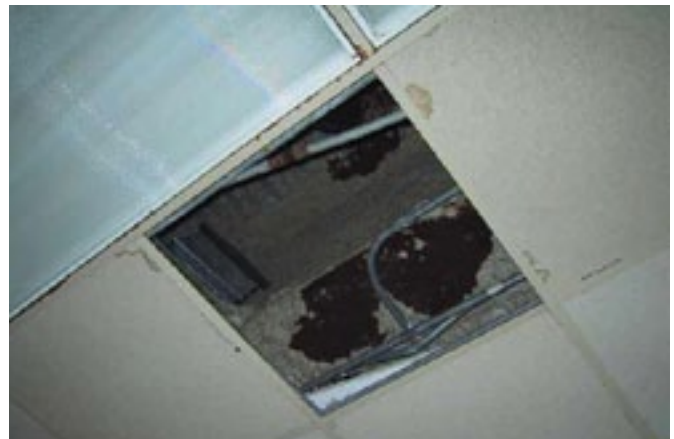
SFRM or IFRM can be damaged when new services are added to existing buildings and need repair and documentation of the repair to comply.
GCP Applied Technologies Photo
